UBC/Pacific Spirit Park Cliff Erosion Management Planning

CONSULTATION DISCUSSION DOCUMENT

July 31, 2000

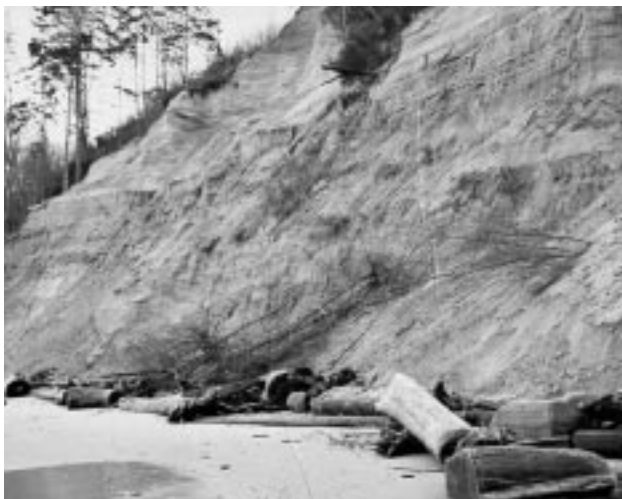
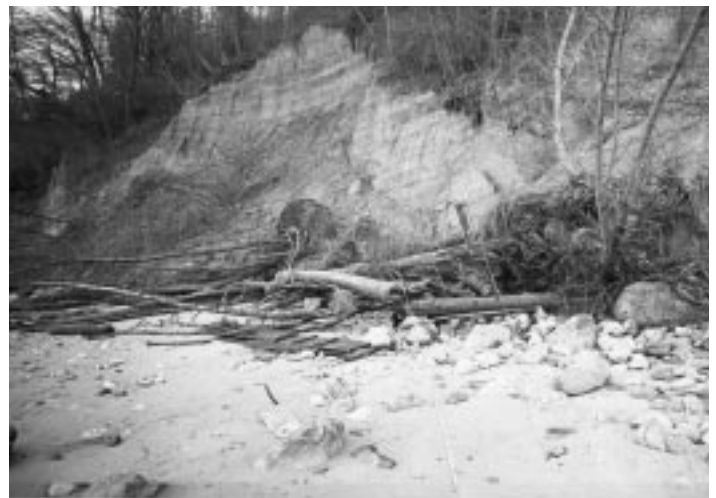
1968 – Low tide showing logs which hit the cliff 4 feet higher at high tide

1968 – Trees and roots on beach as a result of toe erosion

⇒ The berm and drift sill protection works erected in 1981 were evaluated in 1992 for effectiveness. The consultant's review indicated that most of the work had held up well and had been effective in reducing or eliminating shoreline erosion. Some maintenance work was required, particularly at the northern end. Presently, the berm is almost gone in areas of Tower Beach. Much of the cliff base remains exposed to this day and it was also noted that the areas left unprotected had suffered continual damaging erosion. Much of this erosion is due to littoral drift (wave scour aided by logs pounding the cliff toe) at high tide and during storms.

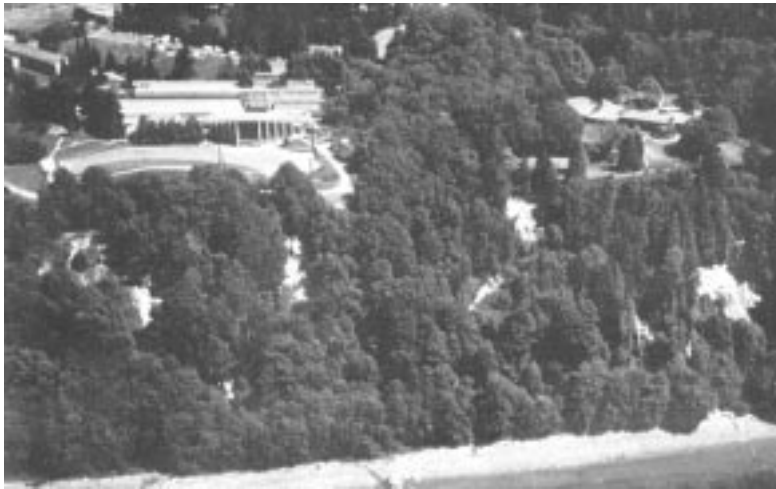
*1998 – Cliffs below
Museum and
Mackenzie House*

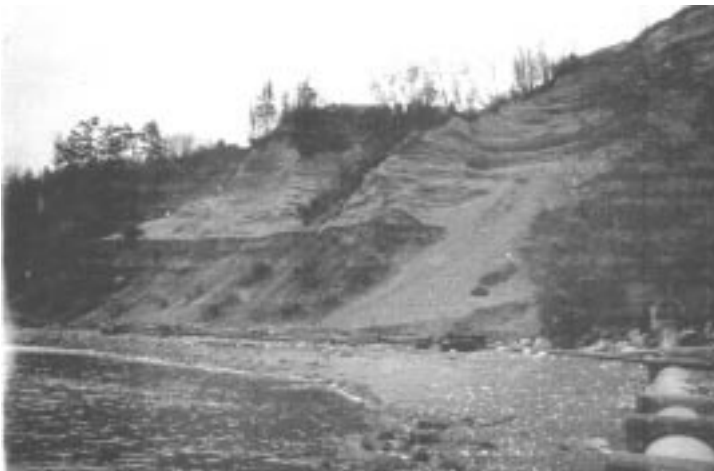
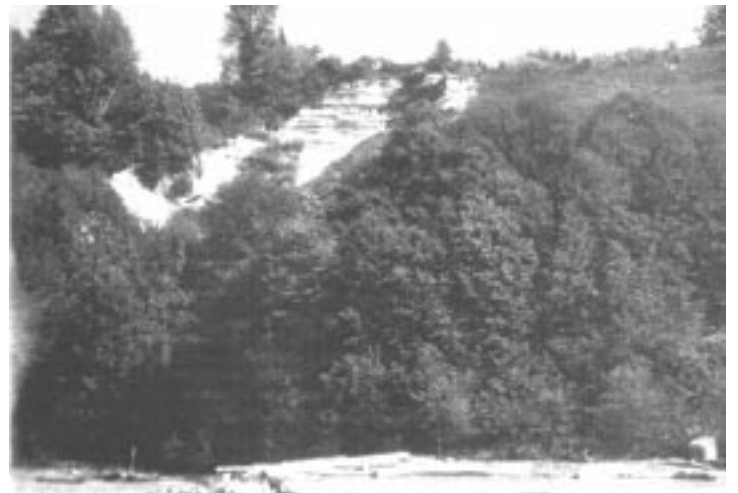
1976

Cliffs below Cecil Green Drive and Museum grounds before and after re-vegetation

1992

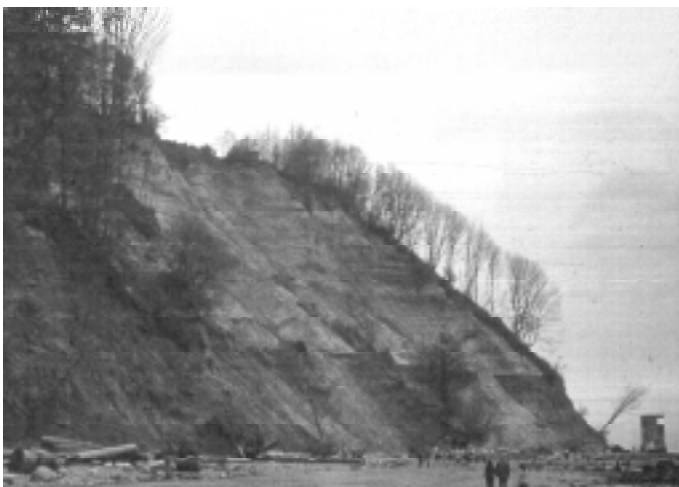
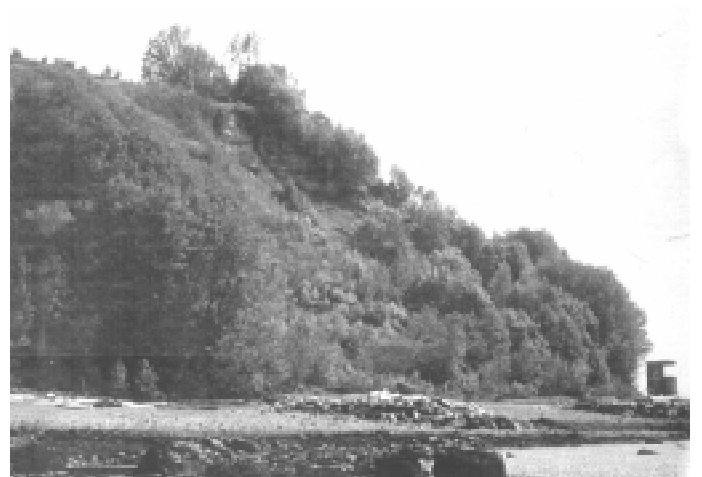
1974

Cliffs below Museum before and after re-vegetation

1992

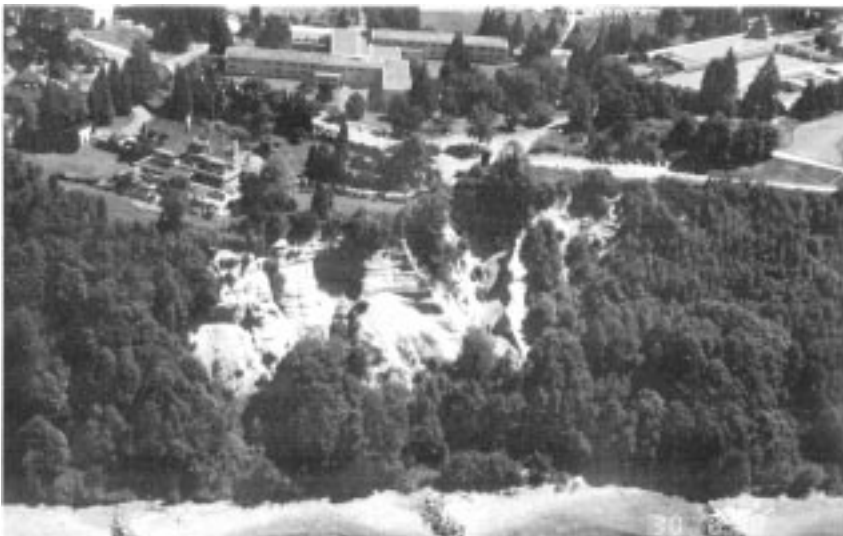
*1998 – View of
cliffs at Cecil
Green House –
note deep gully at
right*

- ⇒ Cecil Green House and Coach House are both effected by erosion. A storm in 1994 caused significant erosion directly adjacent to the Coach House and another storm in 1997 furthered the erosion. These buildings have considerable historical value and their location above the cliffs is a cause for concern.
